# ANNUAL REPORT FOR 2011

**Bald Creek Site #8 Mitigation Site  
Yancey County  
TIP No. R-2518B**

Prepared By:  
Natural Environment Unit & Roadside Environmental Unit  
North Carolina Department of Transportation  
December 2011

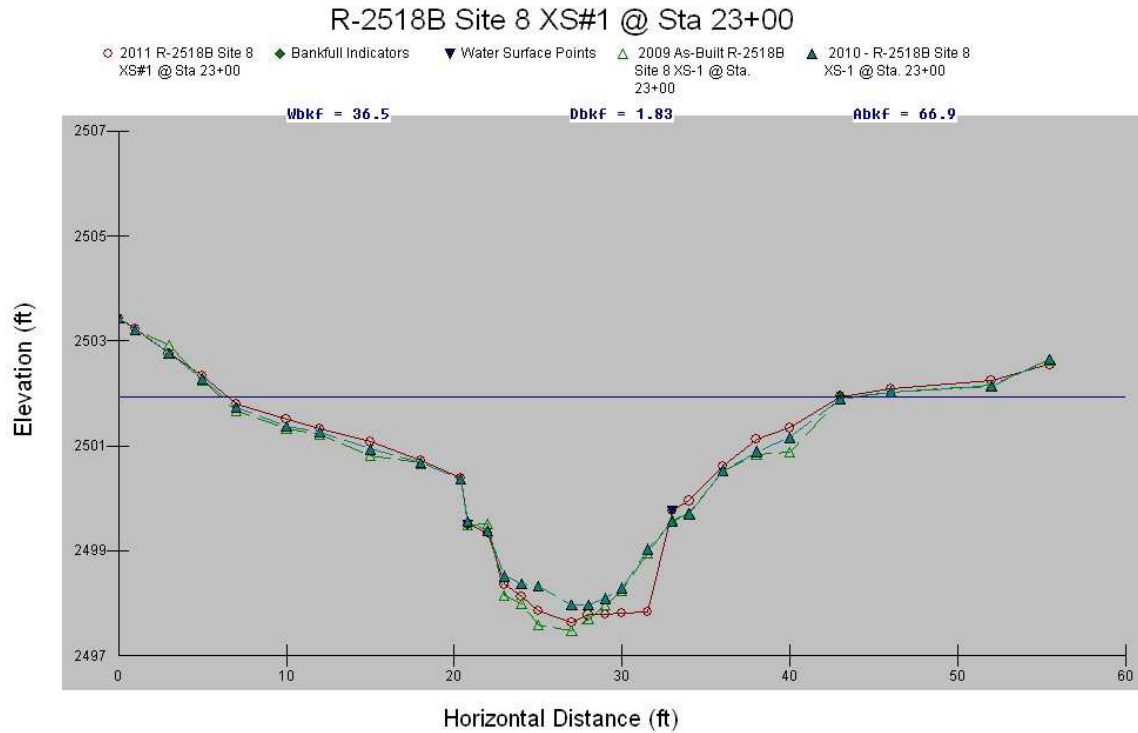
| Site #8: Cross-Section #1 (Pool) Abbreviated Morphological Summary* | | | | | |
| <b>Bankfull Cross Sectional Area (ft<sup>2</sup>)</b> | <b>63.37</b> | <b>66.88</b> | | | |
| <b>Maximum Bankfull Depth (ft.)</b> | <b>3.93</b> | <b>4.31</b> | | | |
| <b>Bankfull Mean Depth (ft.)</b> | <b>1.73</b> | <b>1.83</b> | | | |
| <b>Bankfull Width (ft.)</b> | <b>36.56</b> | <b>36.53</b> | | | |

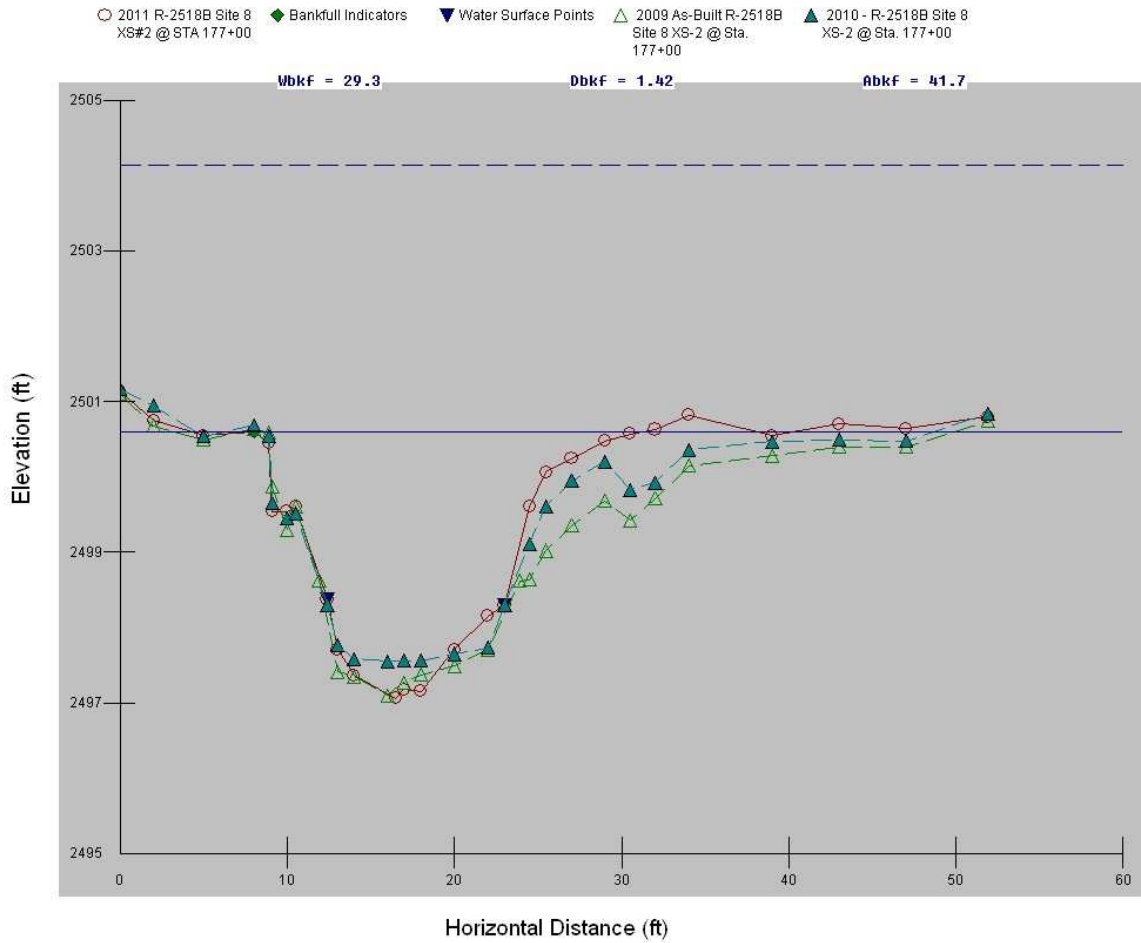
# R-2518B Site 8 XS#2 @ STA 177+00

| Site #8: Cross-Section #2 (Riffle) Abbreviated Morphological Summary | | | | | |
| Bankfull Cross Sectional Area (ft. <sup>2</sup> ) | 39.07 | 41.53 | | | |
| Maximum Bankfull Depth (ft.) | 2.81 | 3.54 | | | |
| Width of the Floodprone Area (ft.) | 51.9 | 51.9 | | | |
| Bankfull Mean Depth (ft.) | 1.56 | 1.79 | | | |
| Width/Depth Ratio | 16.06 | 12.99 | | | |
| Entrenchment Ratio | 2.07 | 2.23 | | | |
| Bankfull Width (ft.) | 25.06 | 23.25 | | | |

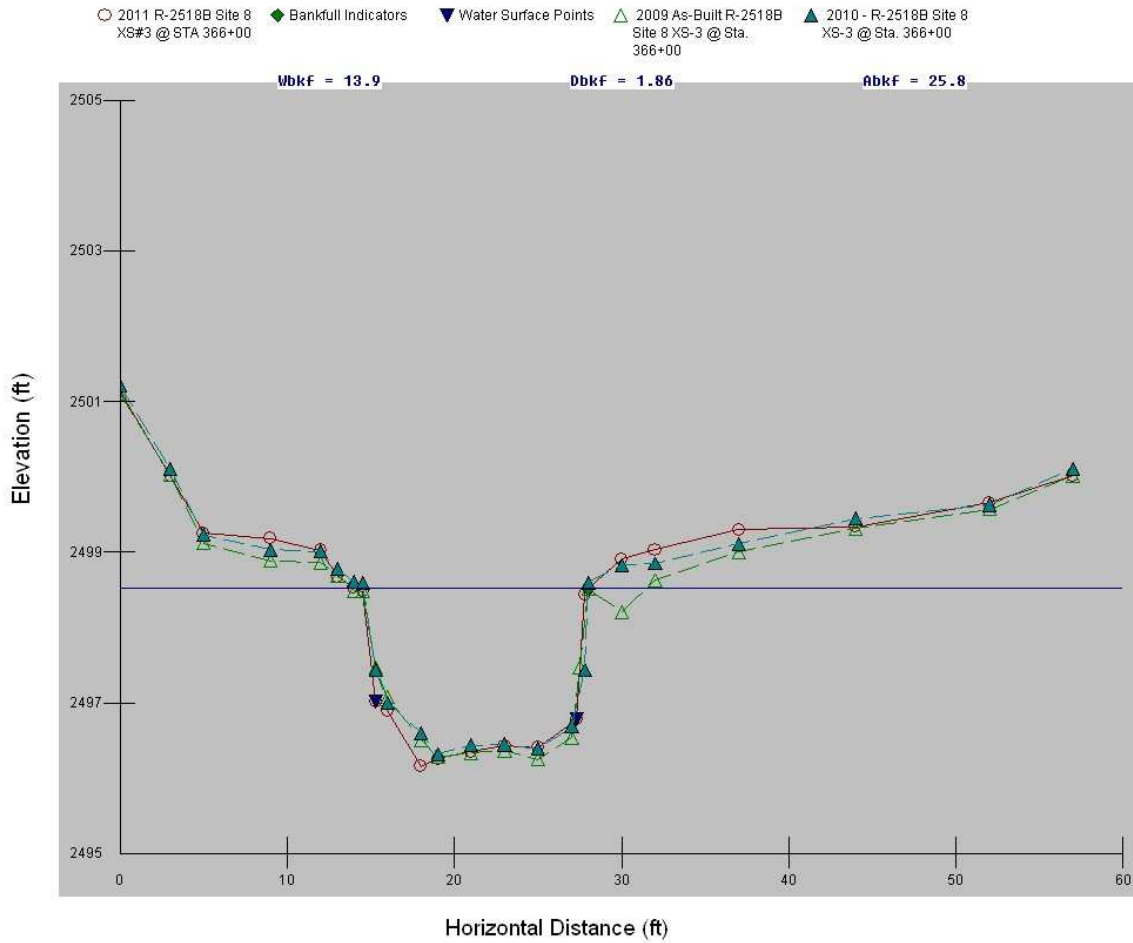
# R-2518B Site 8 XS#3 @ STA 366+00

| Site #8: Cross-Section #3 (Pool) Abbreviated Morphological Summary* | | | | | |
| Bankfull Cross Sectional Area (ft <sup>2</sup> ) | 25.73 | 25.79 | | | |
| Maximum Bankfull Depth (ft.) | 2.28 | 2.36 | | | |
| Bankfull Mean Depth (ft.) | 1.91 | 1.86 | | | |
| Bankfull Width (ft.) | 13.5 | 13.9 | | | |

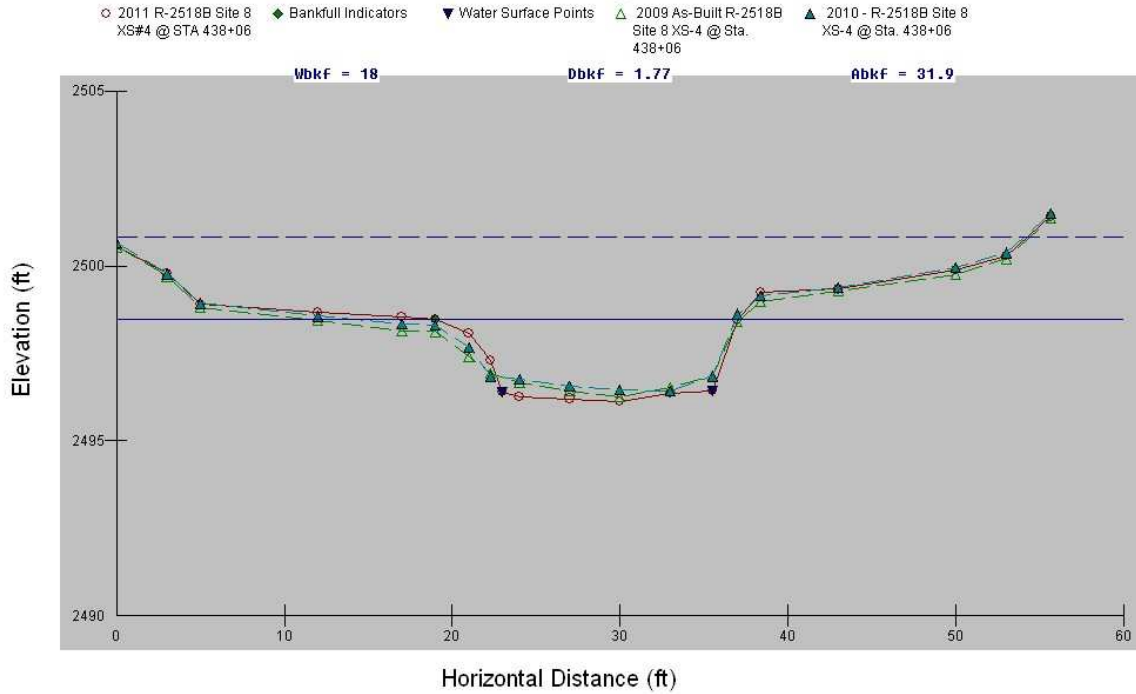
# R-2518B Site 8 XS#4 @ STA 438+06

| Site #8: Cross-Section #4 (Riffle) Abbreviated Morphological Summary | | | | | |
| Bankfull Cross Sectional Area (ft <sup>2</sup> ) | 25.58 | 31.87 | | | |
| Maximum Bankfull Depth (ft.) | 1.88 | 2.36 | | | |
| Width of the Floodprone Area (ft.) | 50.11 | 54.31 | | | |
| Bankfull Mean Depth (ft.) | 1.44 | 1.77 | | | |
| Width/Depth Ratio | 12.32 | 10.19 | | | |
| Entrenchment Ratio | 2.83 | 3.01 | | | |
| Bankfull Width (ft.) | 17.74 | 18.04 | | | |

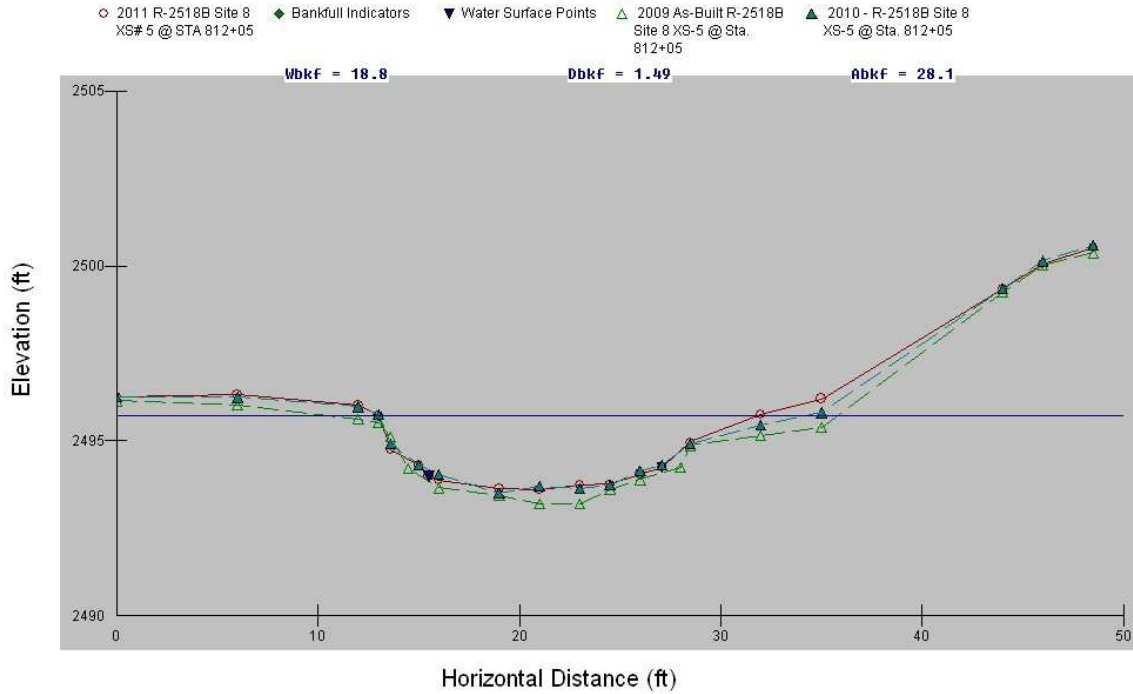
# R-2518B Site 8 XS# 5 @ STA 812+05

| Site #8: Cross-Section #5 (Pool) Abbreviated Morphological Summary* | | | | | |
| Bankfull Cross Sectional Area (ft <sup>2</sup> ) | 29.34 | 28.13 | | | |
| Maximum Bankfull Depth (ft.) | 2.25 | 2.11 | | | |
| Bankfull Mean Depth (ft.) | 1.36 | 1.49 | | | |
| Bankfull Width (ft.) | 21.57 | 18.82 | | | |
